# NAVAL RESEARCH LABORATORY REPORT

Report R-3036

REMOVAL OF EASE REFLECTIONS BY HARP  
IN THE SG INSTALLATION ABOARD DESTROYERS

A study has been made of the antenna patterns for the SG radar installation aboard a destroyer. The reflector and feed were of an improved design with side lobes approximately the same as those of the SG now under development (below 30 db). It is shown that side lobes as high as 21 db are introduced by mast reflections and that they may be eliminated by covering the illuminated section of the mast with Harp. The influence of such side lobes on the PPI presentation when large targets are nearby has also been studied and a marked improvement found with the mast reflections removed by Harp. It is concluded that the benefit derived from lower side lobes in an improved SG antenna can only be realized if provision is made to remove the mast reflections by Harp.

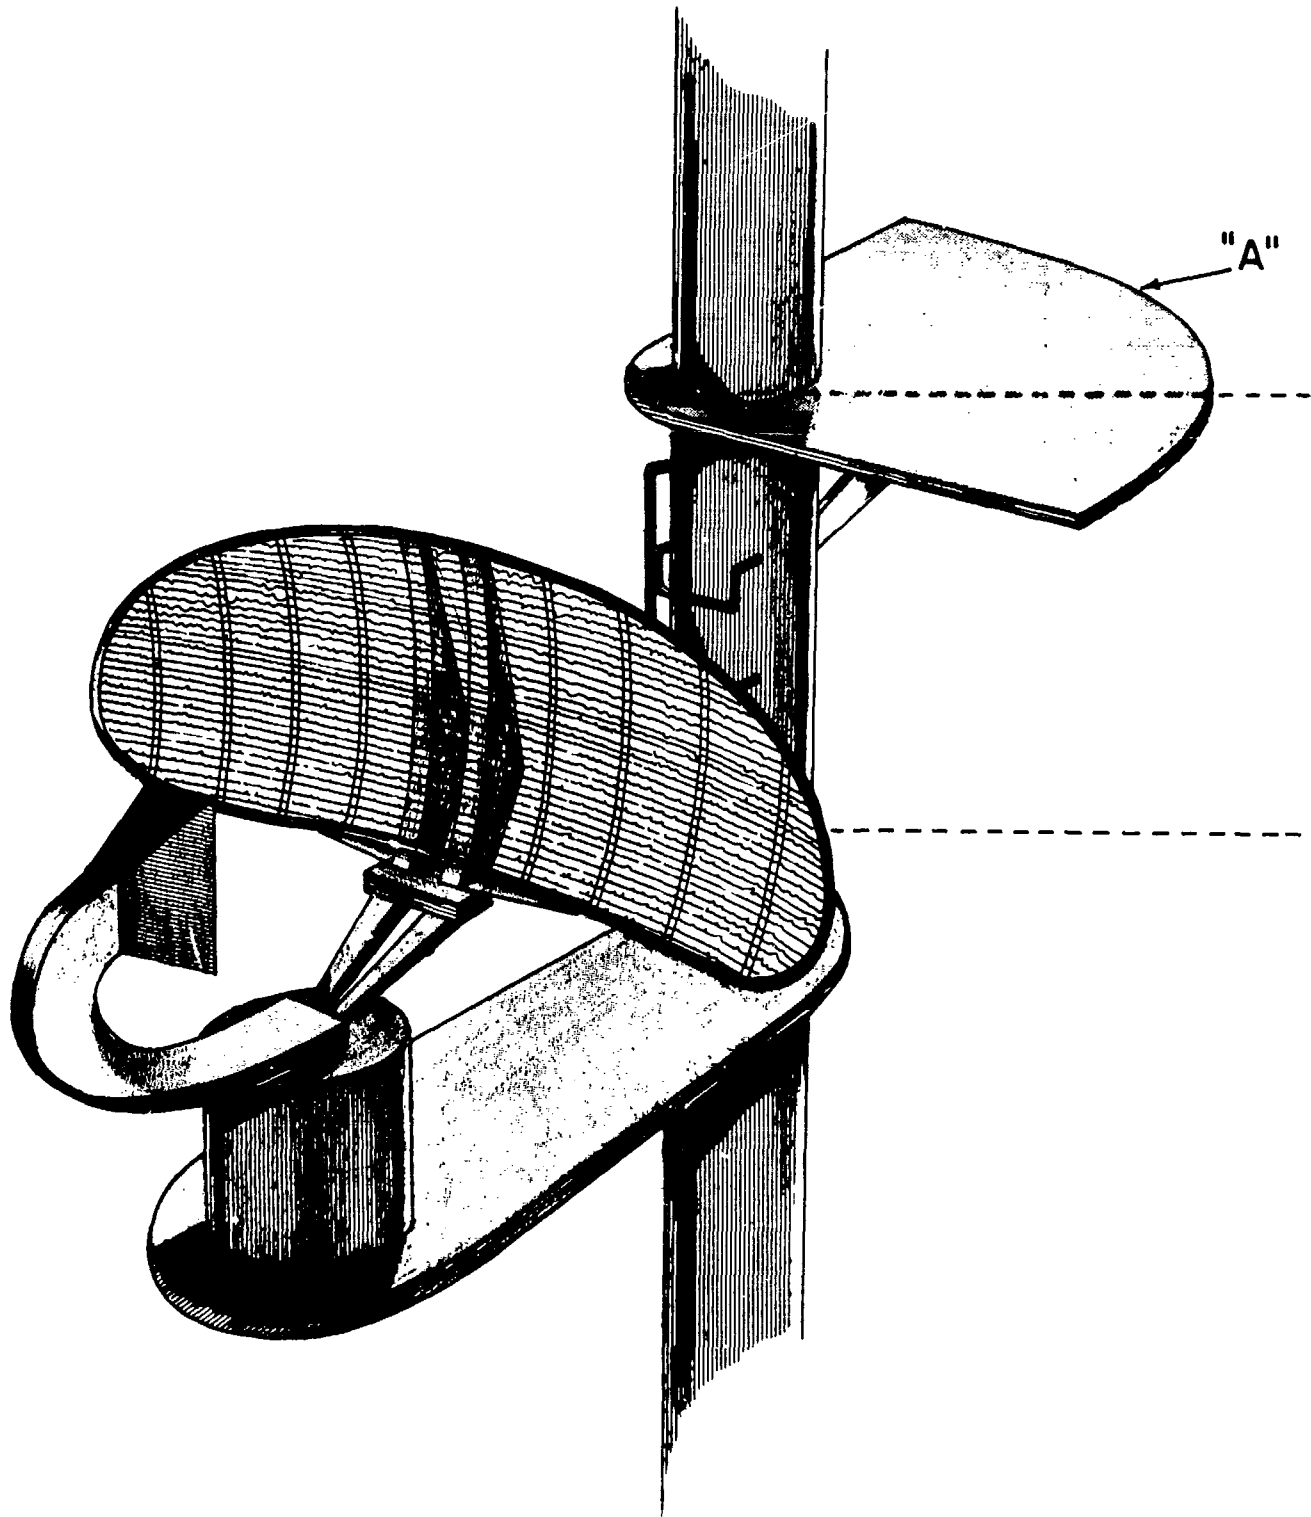
# SKETCH OF SG ANTENNA INSTALLATION ABOARD DD-849

2.1. A sketch of the pedestal and mast for the SG on DD-849 is shown in Plate A. Aside from the location of hand-holds, etc. on the mast, the difference between this installation and that on DD-836 is the platform (marked A) on the port side of the mast which is partially illuminated by the main beam for backward positions of the antenna. A left - right asymmetry is thereby introduced which was not present in the tests described in reference I. The area covered when the Harp absorber was in place is indicated by dotted lines in Plate A.

3.3. It will be noticed that the patterns do not exhibit the left - right symmetry that might be expected and was found in the previous tests. This is probably caused by the platform mentioned in paragraph 2.1 and marked by A in Plate A. This metallic structure intercepting a part of the beam on the port side of the mast can cause a substantial difference in the mast reflections on the port and on the starboard sides.

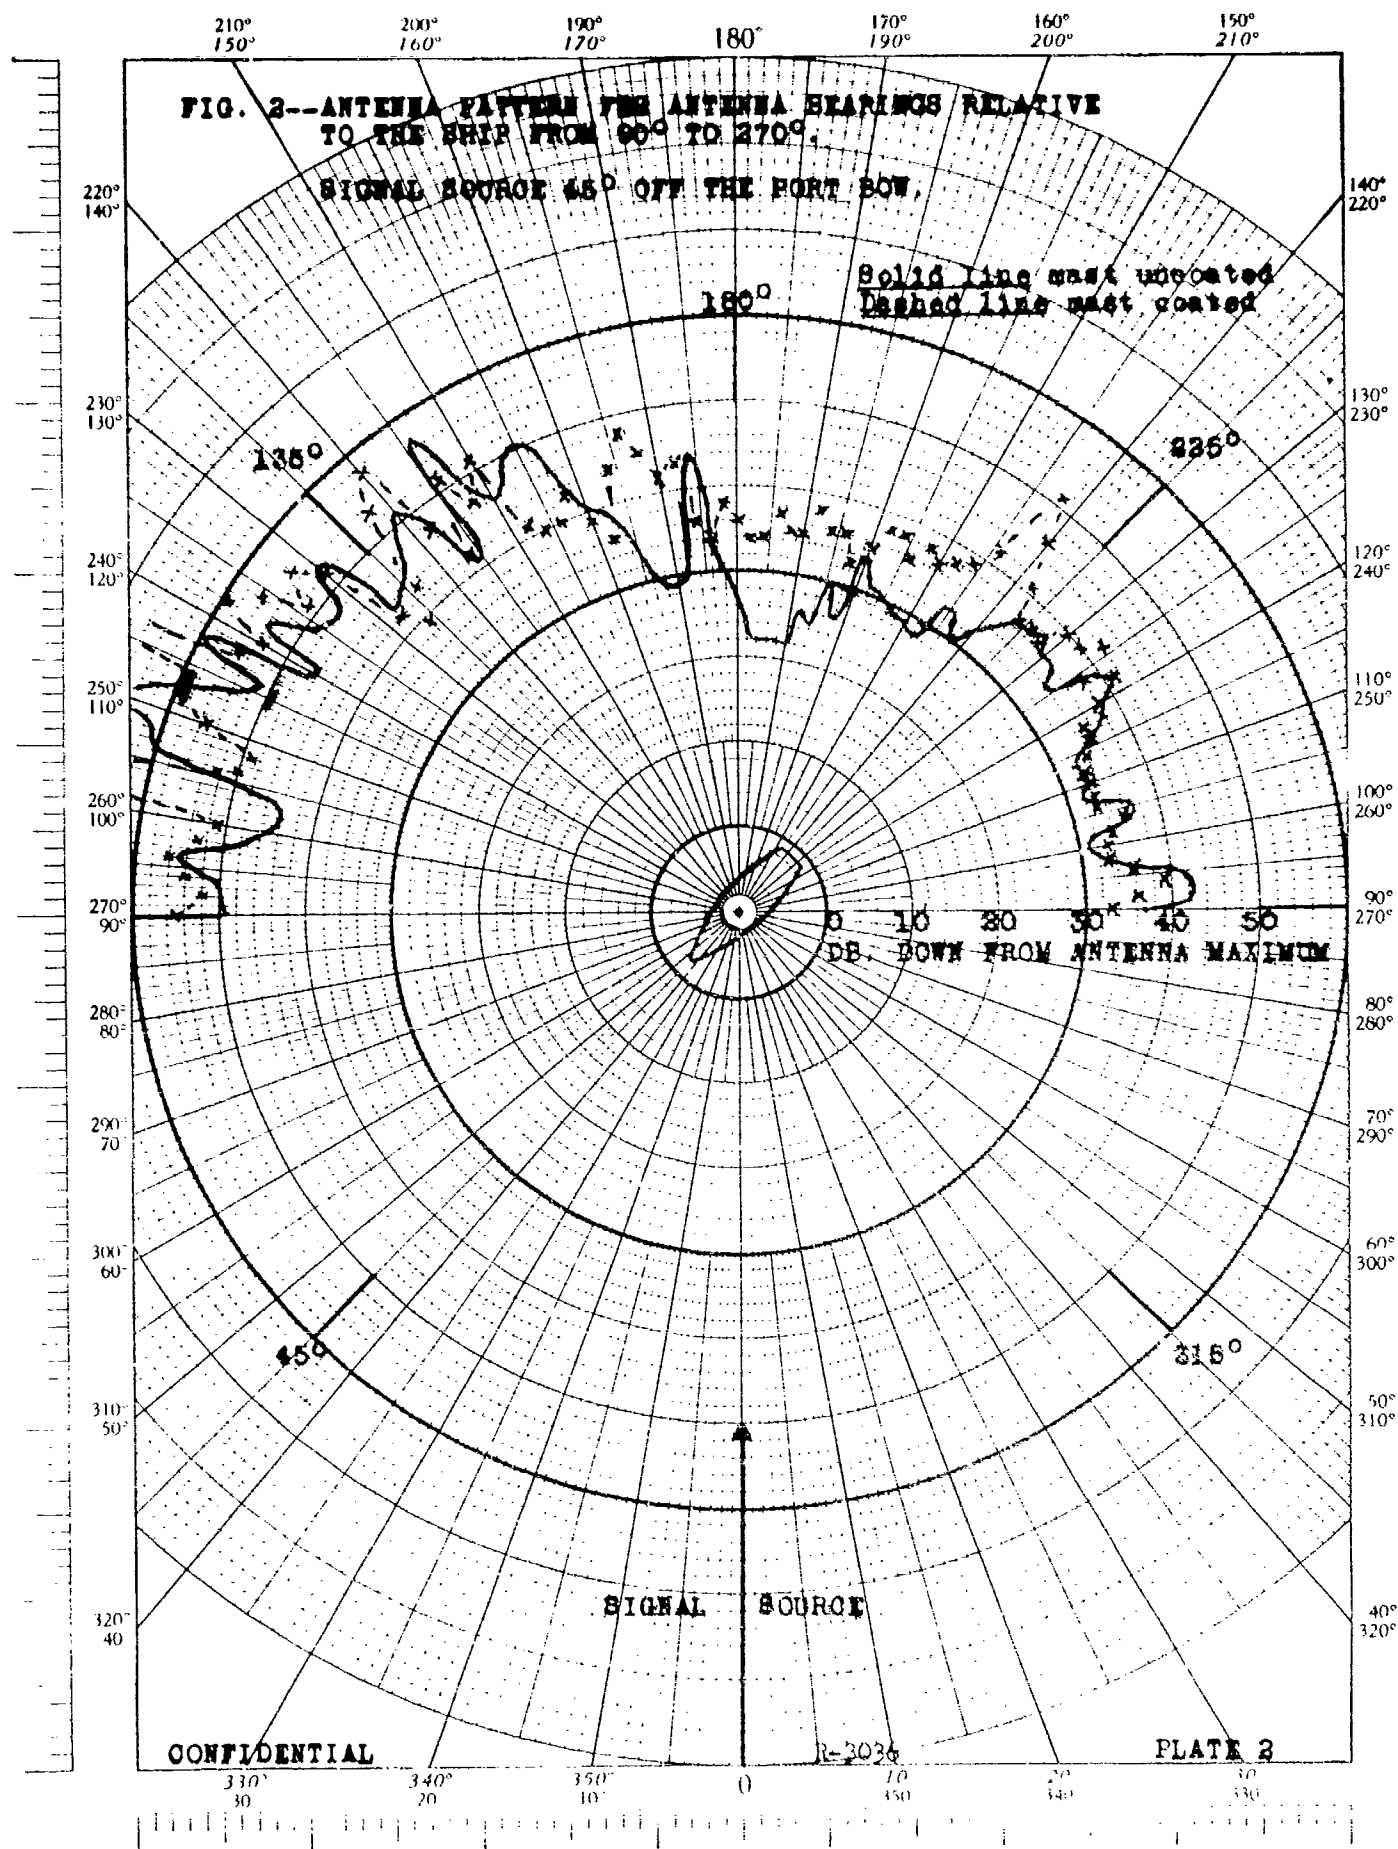
3.2. Sizable mast reflections which are removed by Harp appear in Plates 2 and 5.

<u>Plate</u> <u>No.</u>	<u>Bearing of Source</u>	<u>Antenna</u> <u>Bearing</u>	<u>Height of</u> <u>Side Lobe</u>	<u>Height After</u> <u>Harp</u> <u>Installation</u>
2	45° off port bow	185	22 db	35 db
5	90° off starboard bow	160	26 db	50 db

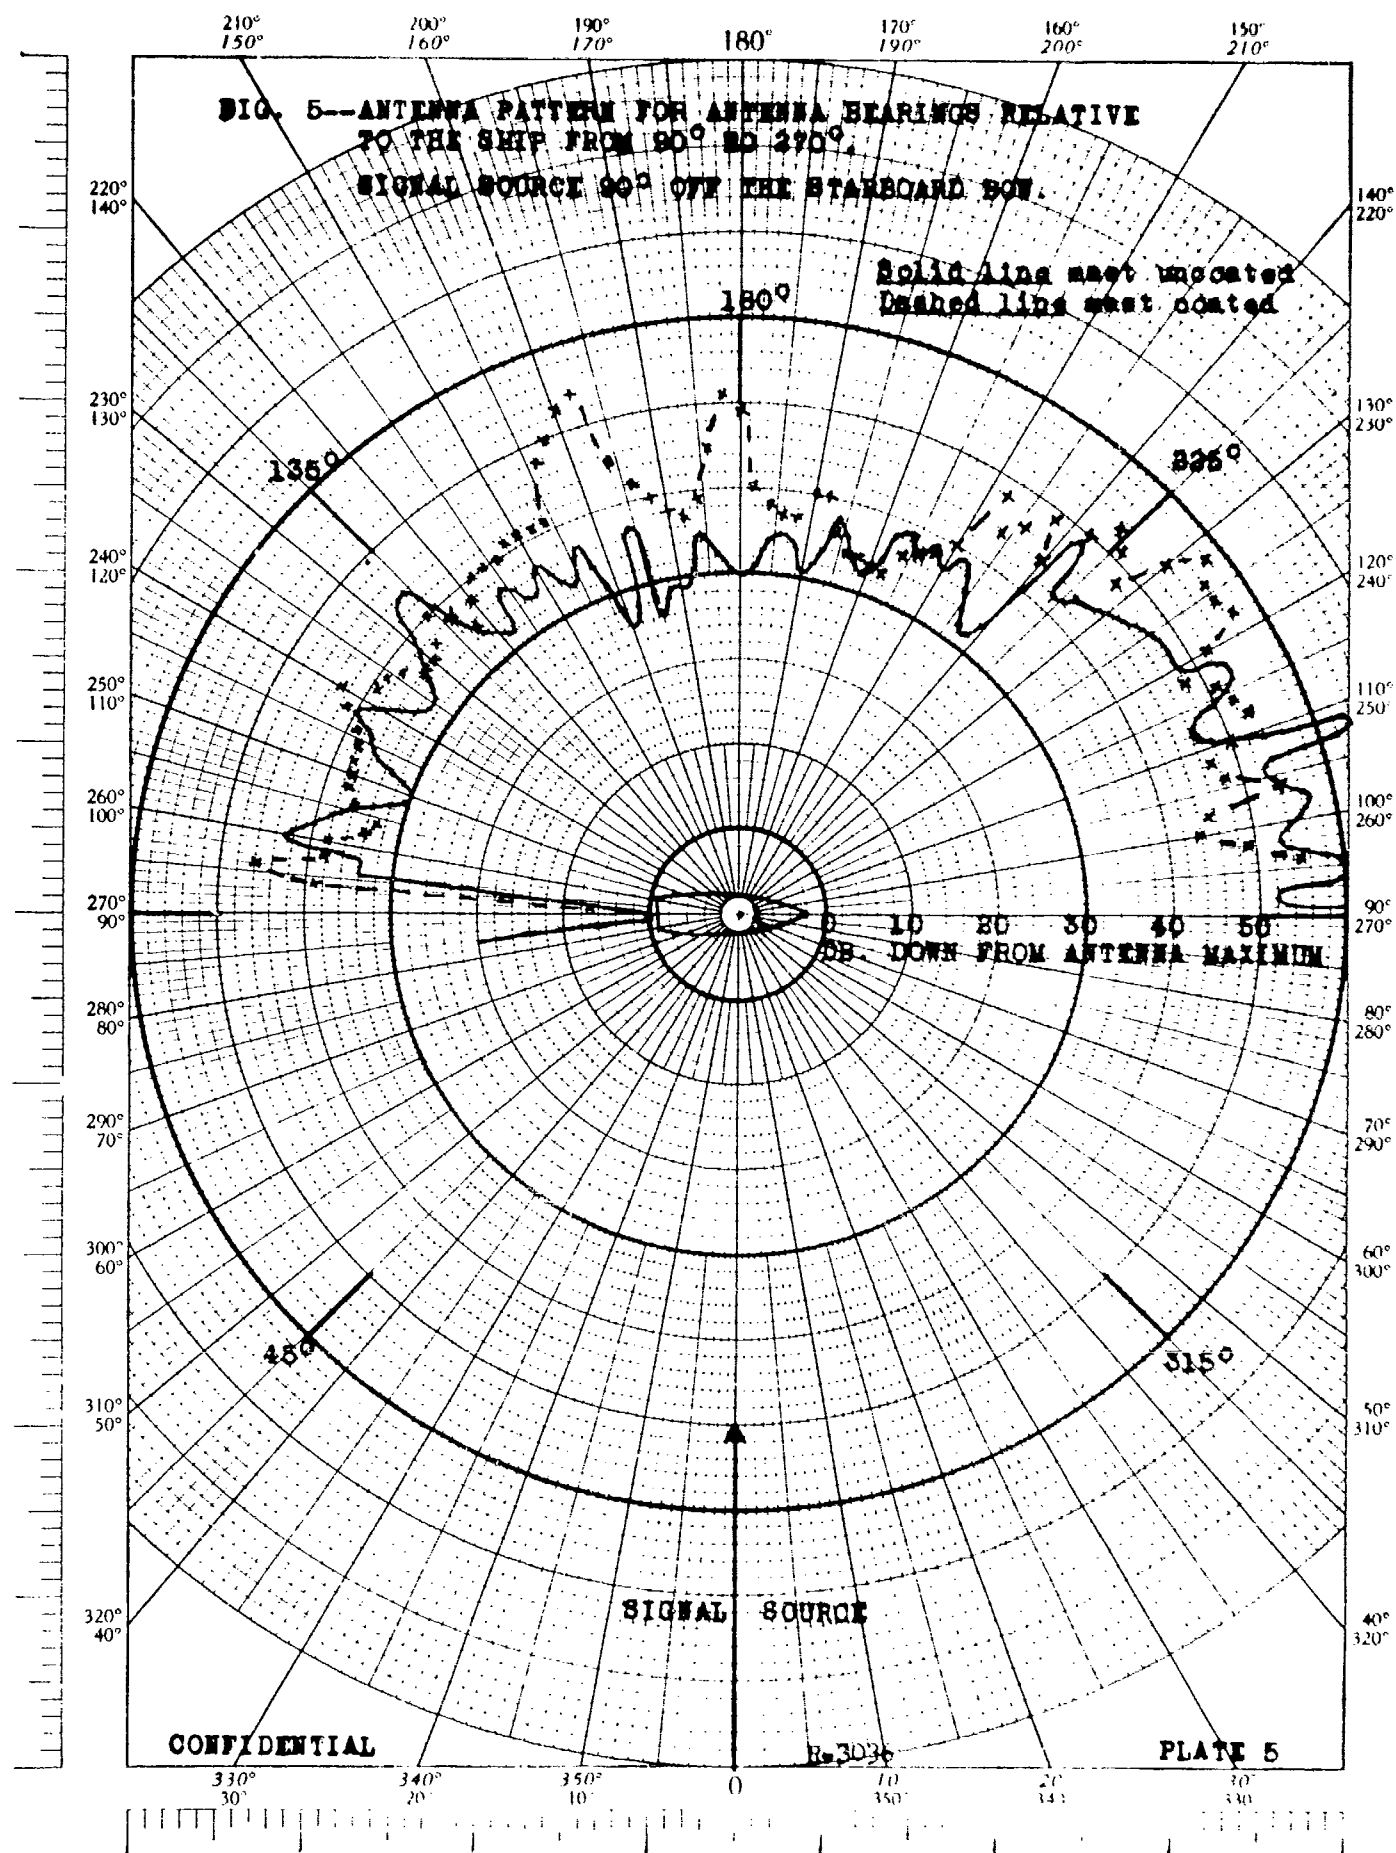
3.4. The pattern with the target directly off the stern (Plate 5) shows clearly the effect of the mast obstruction both in widening the beam and in causing a minor lobe to appear at 6° from the center of the main beam on both sides. The distortion of the main beam causes a serious loss in antenna gain for this position

of the antenna (See paragraph 3.7). It should be remembered in considering the side lobes in this pattern that, because of the decreased antenna gain, the center of the main beam is 11 db below the center of the main beam for antenna positions in which the reflector is not obstructed by the mast.

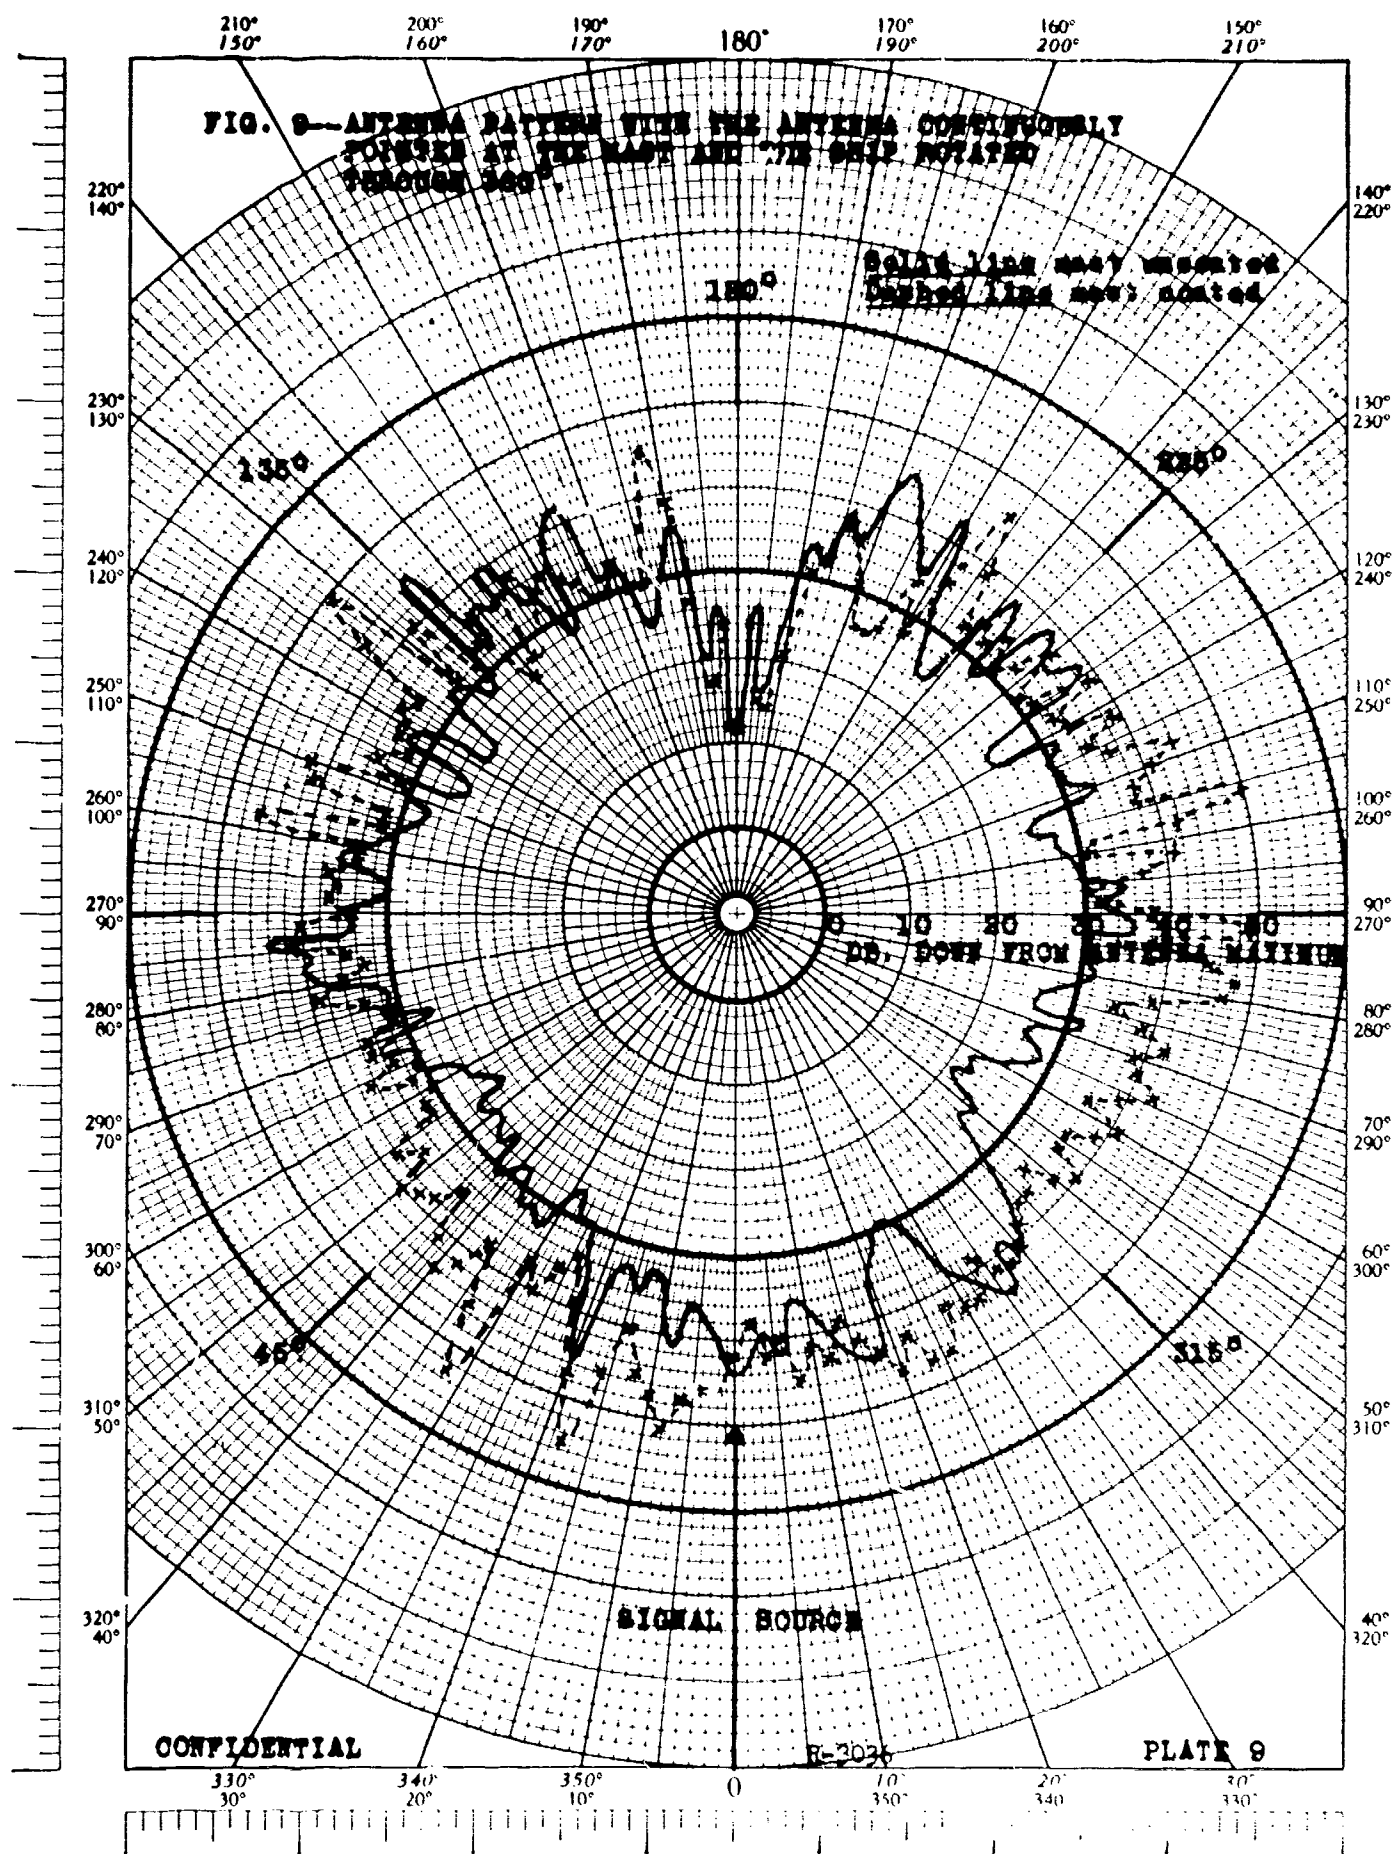
3.5. An antenna pattern with the reflector trained directly at the mast while the ship's head turned through 360° is shown in Plate 9. The points on this curve should correspond to points on the curves of Plate 1 to Plate 8, inclusive, at antenna bearing of 180°. Sizable mast reflections appear as follows:

<u>Bearing</u>	<u>Height of Side Lobe</u>	<u>Height After Harp Installation</u>
55°	23 db	32 db
125°	24 db	33 db
135°	24 db	33 db
240°	24 db	33 db
305°	21 db	35 db

These side lobes are measured with respect to the main beam when there is no obstruction between the antenna and signal source.

3.6. Study of these patterns reveals that side lobes from the mast reflections appear in many positions and are sometimes as high as 21 db down. When the illuminated section of the mast is covered with Harp, however, all side lobes of the antenna system are reduced below 27 db.

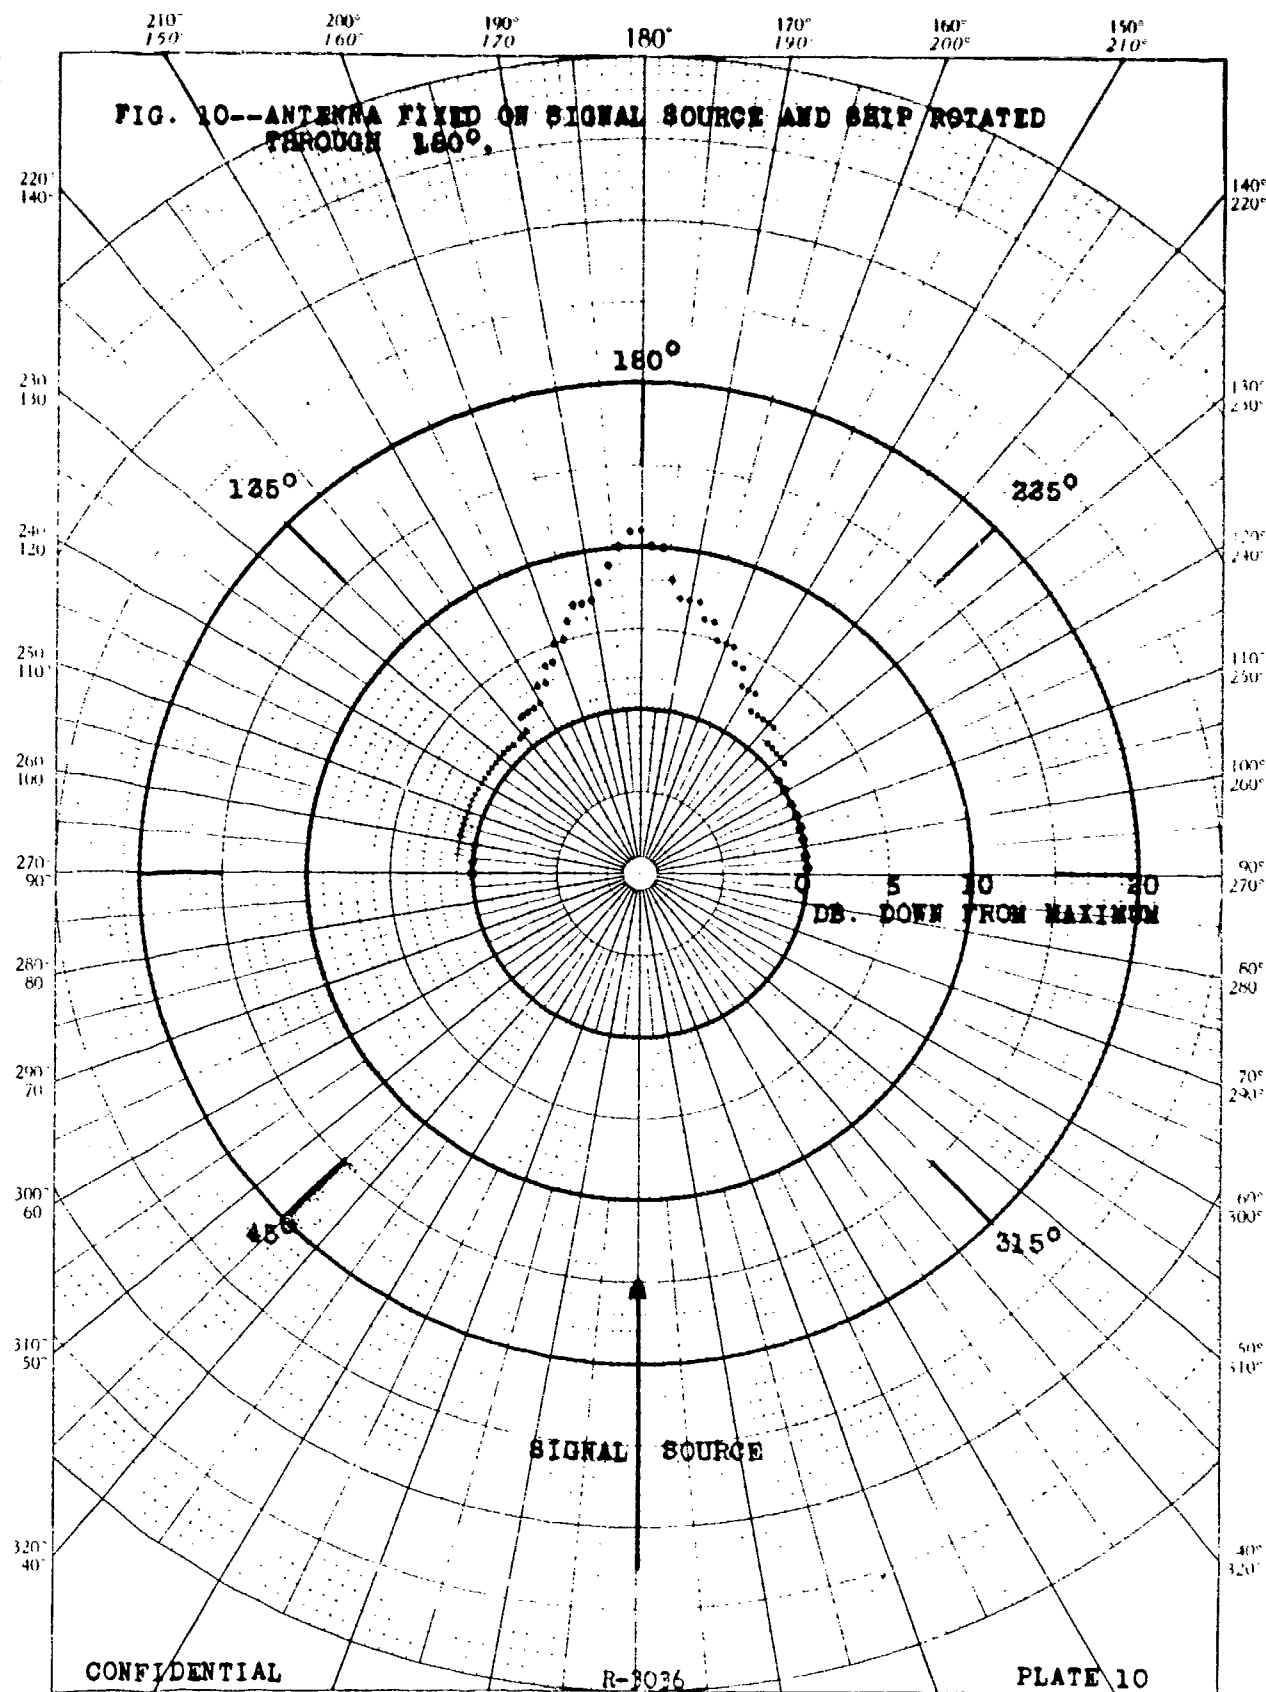
FIG. 10--ANTENNA FIXED ON SIGNAL SOURCE AND SHIP ROTATED THROUGH 180°.

3.7. The ship's pattern was taken with the antenna trained directly on the signal source and the ship's head at various bearings between 90° and 270° relative to the signal source. As there was no significant difference when Harp was in place, only one curve has been plotted in Plate 10. (It should be noted that the radial scale has been changed in this figure). A loss of 11 db appears when the mast is directly between the signal source and the reflector and a loss of 5 db or more is present in a sector of 40° centered in the backward direction. The 11 db loss corresponds to a 22 db loss in radar performance and is approximately twice (in db) as great as that found on DD-836. This undoubtedly arises from the improved design of the MTI antenna for reduction in side lobes from the reflector is obtained by illuminating the center of the reflector more strongly and tapering the illumination to zero at the edges. Hence, close to the antenna, the radiated energy is more concentrated at the center of the beam and therefore is more strongly affected by an obstacle (the mast) of a fixed size.

5.4. With the same antenna there is an 11 db loss in gain with the antenna trained directly backwards which is not affected by Harp.
